# Manhole Inspection Summary

Manhole # S37YY\_004MH

Insp Date: **12/28/06 2:06 PM**

**Location** Address: **3122 GREENMOUNT AVE**

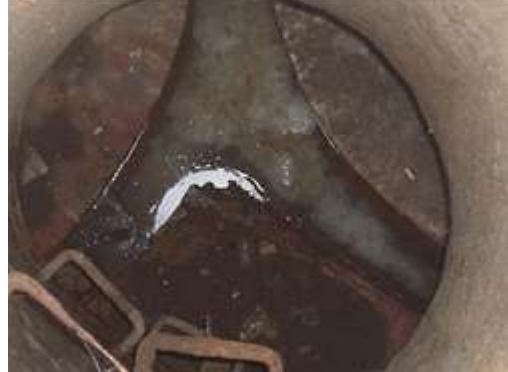
Top View

Corroded steps. Evidence of surcharge - Bench debris. Channel debris.

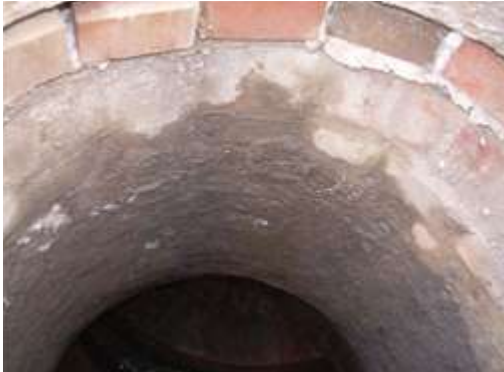
Defect

Frame leaks. Adjustment deterioration, loose brick and infiltration. Corbel infiltration.

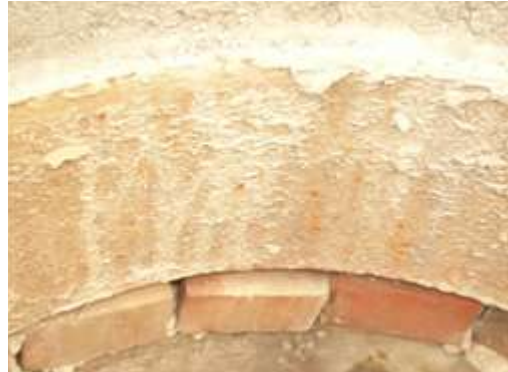
Defect

Frame leaks. Adjustment deterioration, loose brick and infiltration.

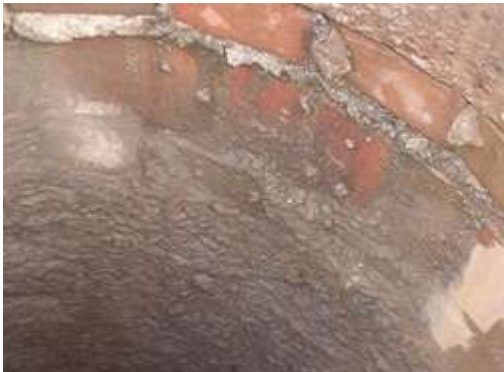
Defect

Frame leaks. Adjustment and Corbel infiltration.

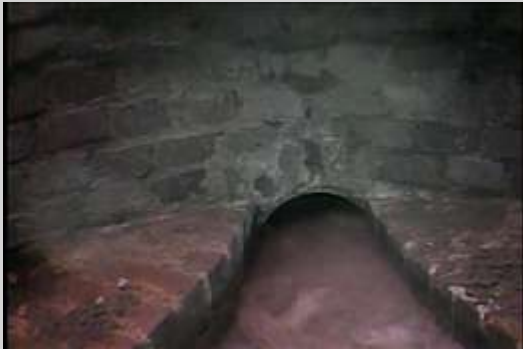
### 8 in. Circular Gravity Sewer Pipe Out @ 12 O'Clock

Deposits: ☐ None ☒ **Mud** ☐ Sludge ☐ Debris ☐ Grease

Silt Depth: **5** (in.) Deposits Extent: **Medium**

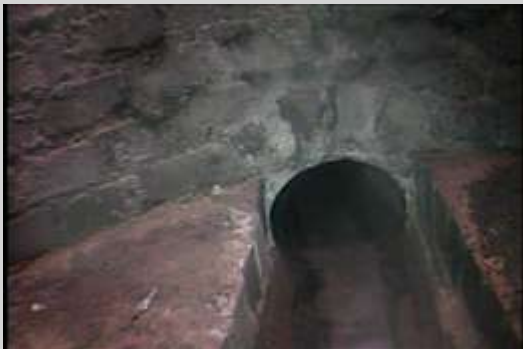
### 8 in. Circular Gravity Sewer Pipe In @ 4 O'Clock

Deposits: ☐ None ☒ **Mud** ☐ Sludge ☐ Debris ☐ Grease

Silt Depth: **3** (in.) Deposits Extent: **Light**

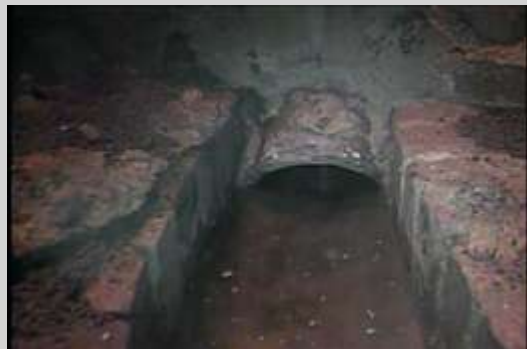
Pipe In @ 7 O'Clock

Deposits: ☐ None ☒ **Mud** ☐ Sludge ☐ Debris ☐ Grease

Silt Depth: **5** (in.) Deposits Extent: **Medium**
